## 25-120(A): Low Signal/Noise Problem

The 25-120 and 25-120A cylindrical mirror analyzers (CMA) have an electron multiplier which can be seen in Figure 1. These analyzers can be found on PHI 595, 600 and 660 Scanning Auger Systems.

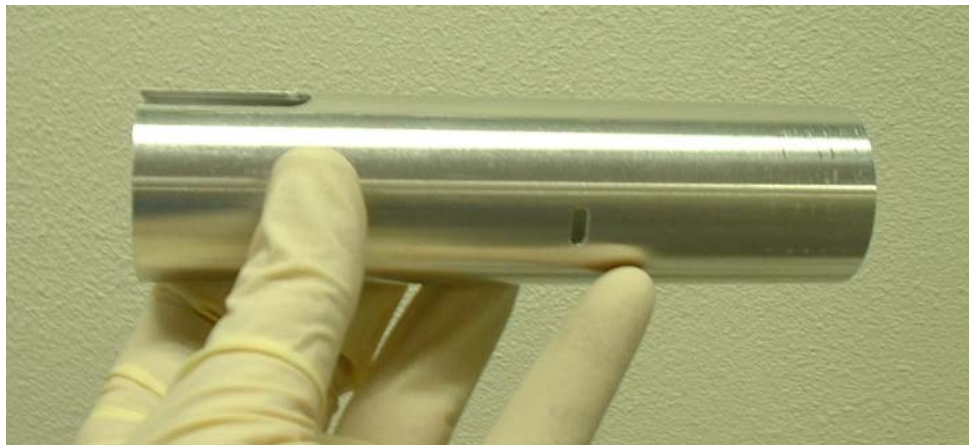
Figure 2. Multiplier cover

The multiplier has an aluminum cover (Figure 2) that can slide down and short out the collector housing. When this happens, the signal to noise ratio is reduced by a factor of three. Fortunately, this is an easy problem to diagnose and fix.

1. Vent the system and remove the electron multiplier from the CMA.
2. Slide the cover off of the multiplier.
3. Cut off ¼" of the cover from the end that is closest to the collector housing. In Figure 2, this is the right side of the picture.
4. "De-burr" the cover and clean it with a laboratory cleanser such as Alconox, followed by isopropanol, to remove any oils deposited during the cutting process.
5. Install a new gasket on the multiplier flange.
6. Slide the cover back over the multiplier assembly.
7. Re-install the electron multiplier into the CMA. See Figure 3.
8. Measure the NEG connector to the CMA to make sure that the resistance is now 3.0 Meg ohms.
9. Pump down the system.
10. Bake the system.
