www.rbdinstruments.com

PHI X-ray Source Bake-Out Tips

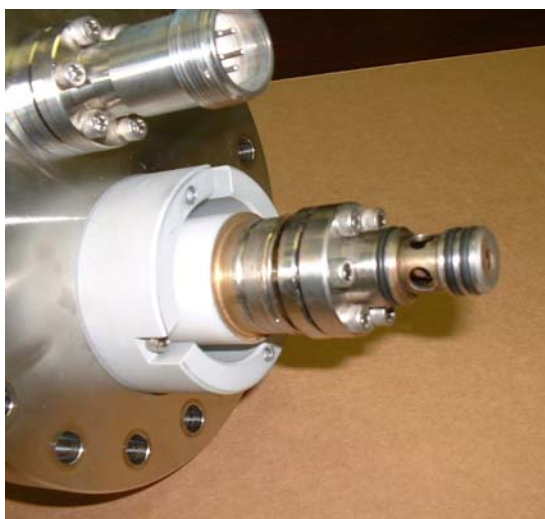
When the 10-550/10-560 x-ray source is baked-out, the Teflon block that directs the water into and out of the source needs to be removed. Also remove the Viton O-rings on the anode that are exposed after the Teflon block has been removed. If the O-rings are not removed for bake-out, they will dry out and cooling water will leak past them during normal operation of the x-ray source. The result is that carbon arc lines form inside the Teflon block that eventually cause water leaks and/or high voltage leakage across the anode. This problem is easily prevented by simply removing the O-rings before the system is baked-out. A picture of the O-rings is shown to the right.
